Arboricultural Report

REVISED TREE SURVEY INFORMATION FOR
FALCON ROWING AND CANOEING CLUB
DONNINGTON BRIDGE
OXFORD

February 2010

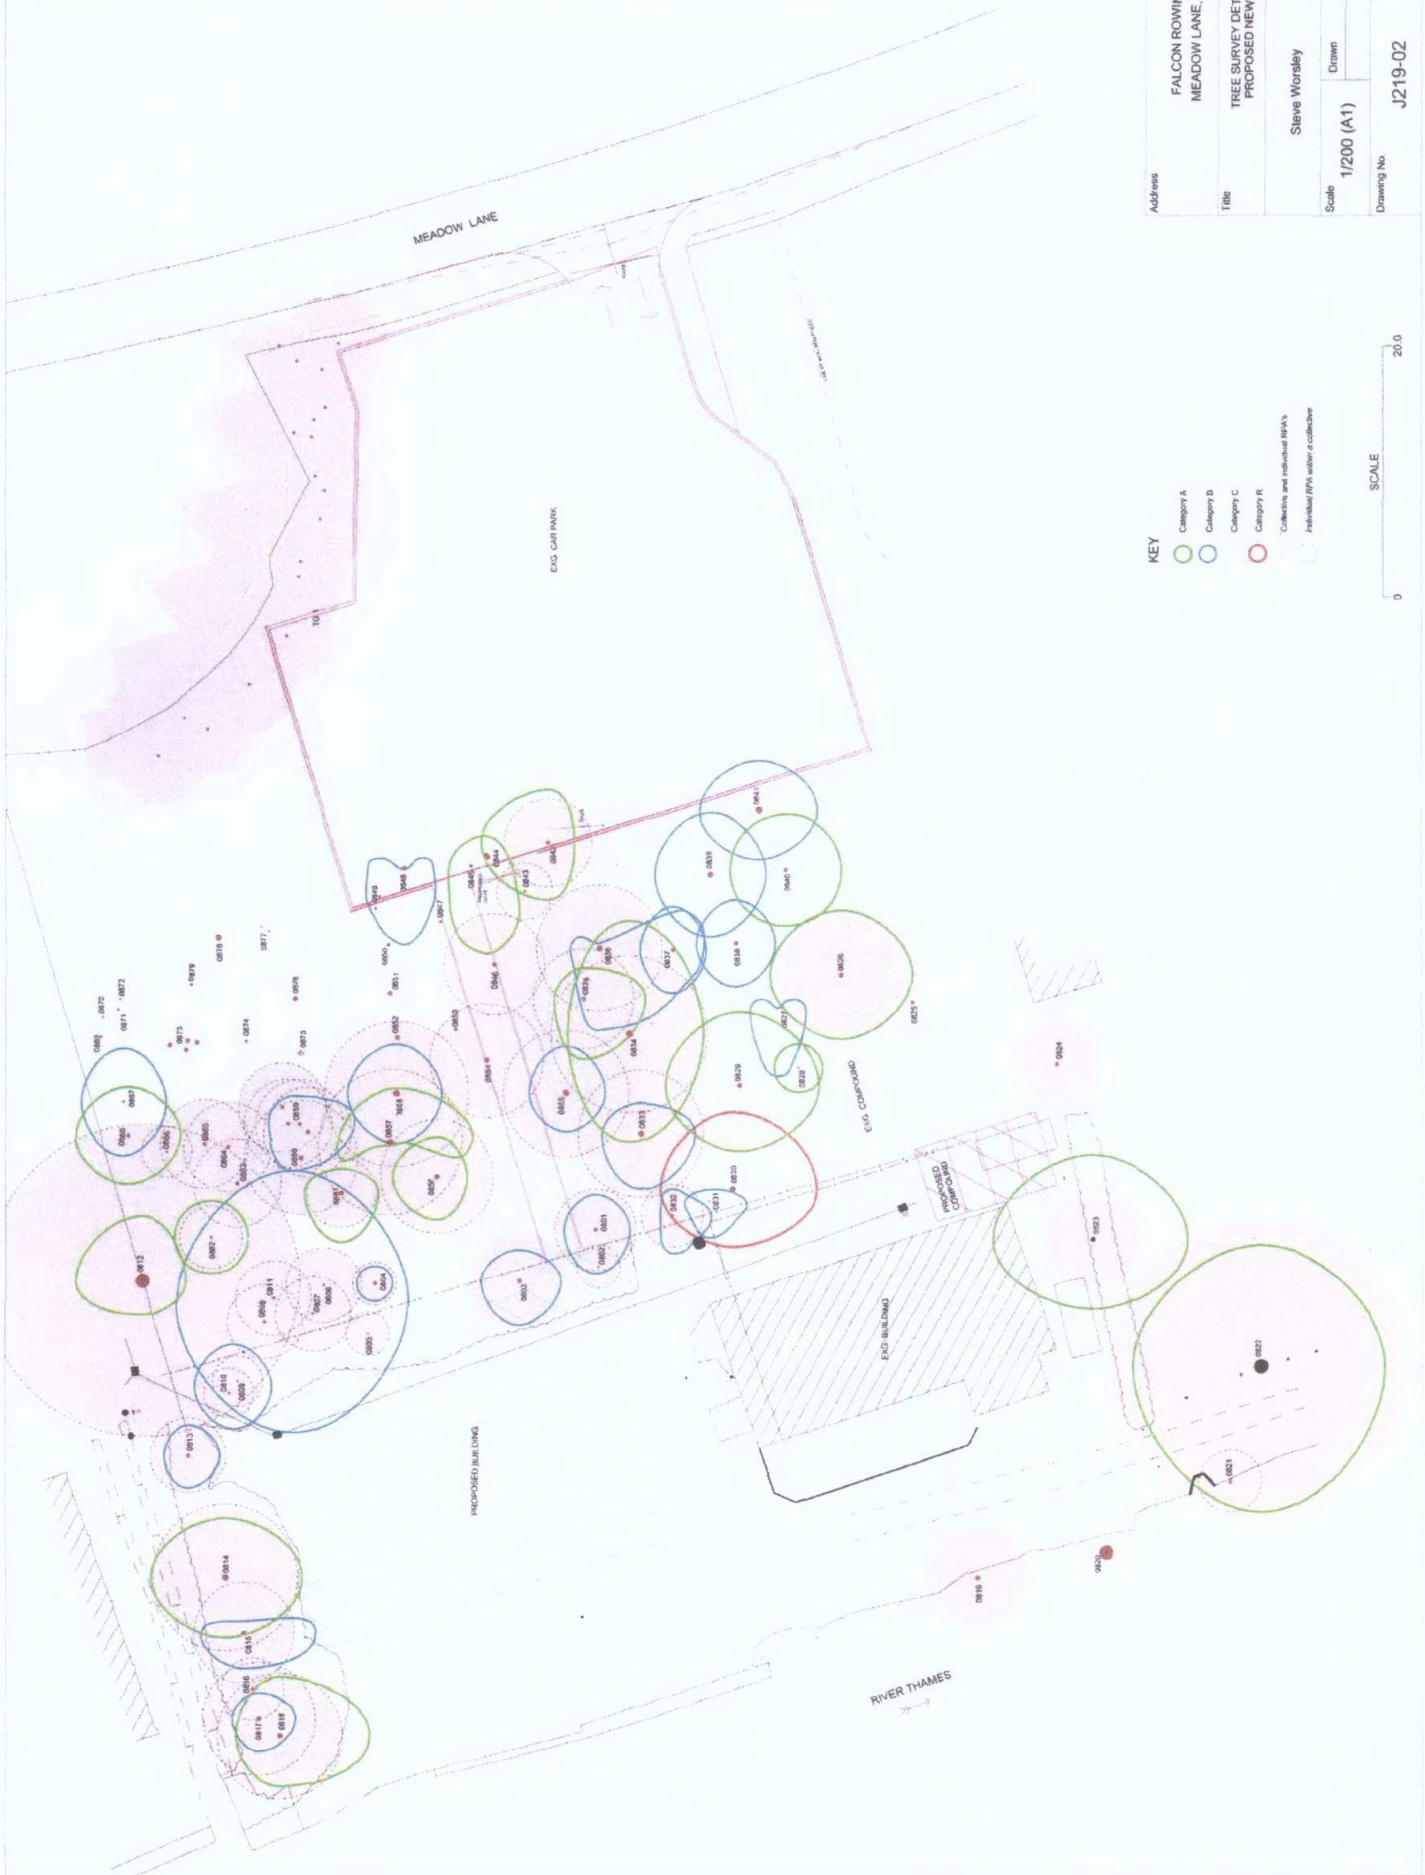
Tree quality and Root Protection Areas (m²)

- 12.1 A total of just four trees are preferred for removal. Three would pose a significant constraint to the development of the site and one is recommended for removal on safety grounds. These are T801, T802, T803 and T830.
